REP-#153

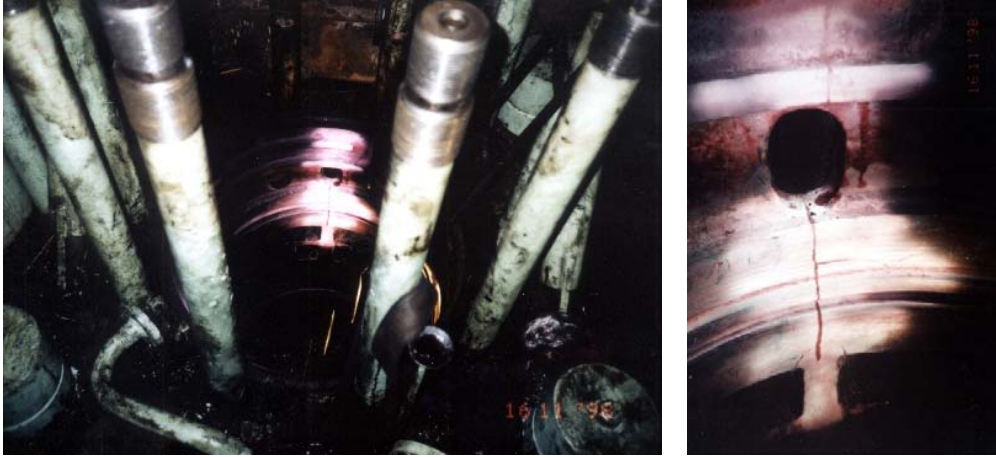
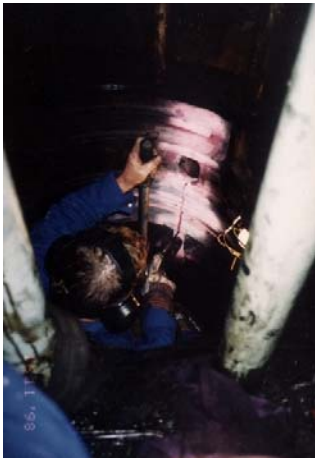
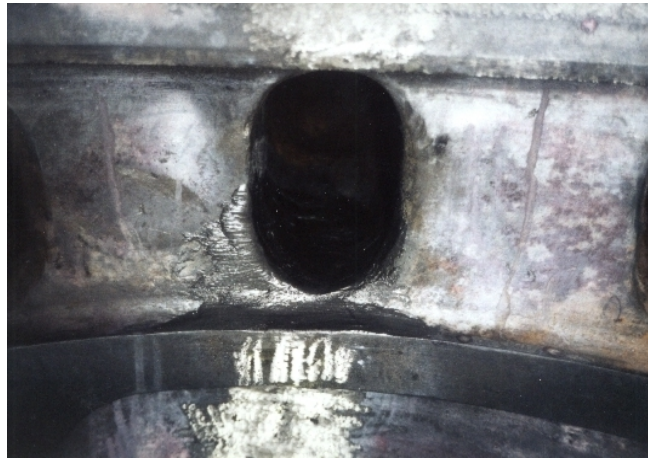
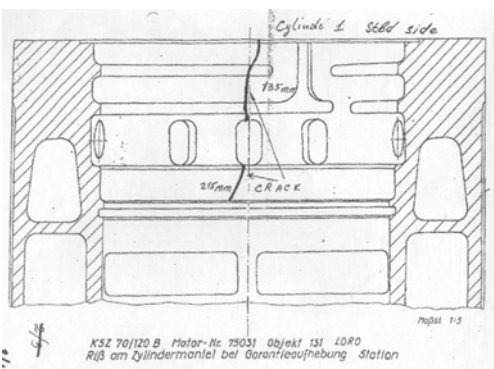
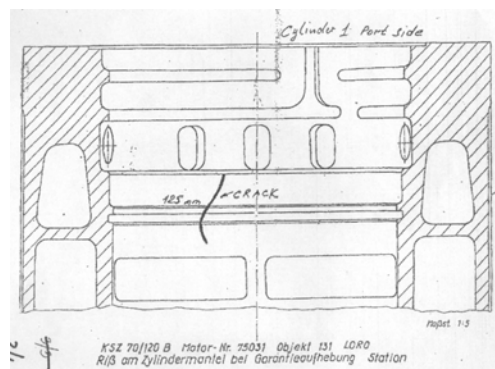
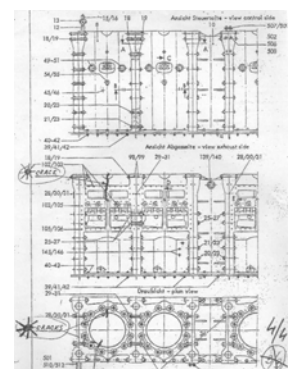
Several cracks in cylinder no. 1 in the main engine block of a ship diesel engine, which probably occurred due to aging and vibration, have been closed with MM-metal SS-steelceramic and Hardener yellow. The cylinder jacket had long vertical cracks of 215 mm and 125 mm length and two further cracks of 135 mm each in the upper area. Even 7 years after the repair has been carried out, the repaired ship engine is in operation without complaints. The extreme difficult repair has been completed by our Netherlands partner company („EMHA technisch bureau b.v.“) and company Metalock in a port in Thailand.
