Worldwide repairs carried out with PolymerMetal®

REP-# 113

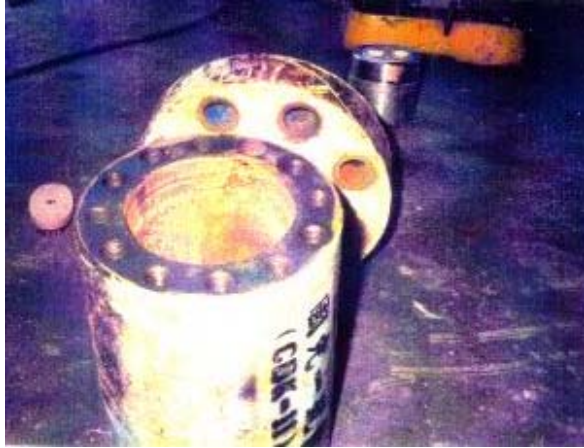
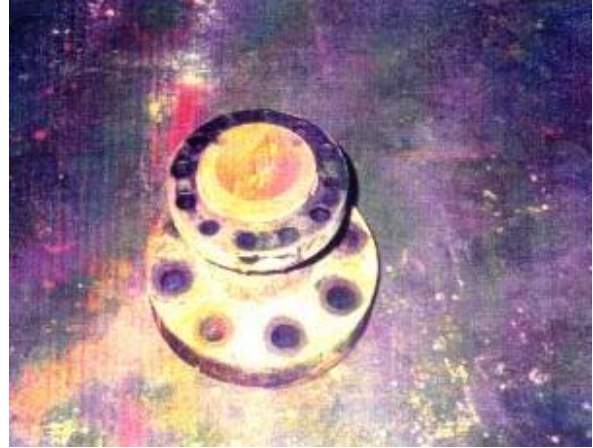
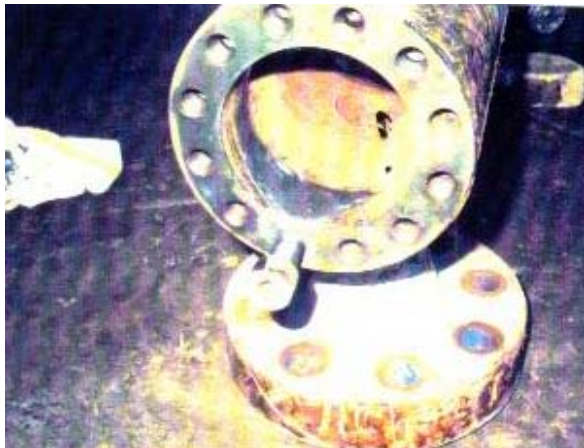
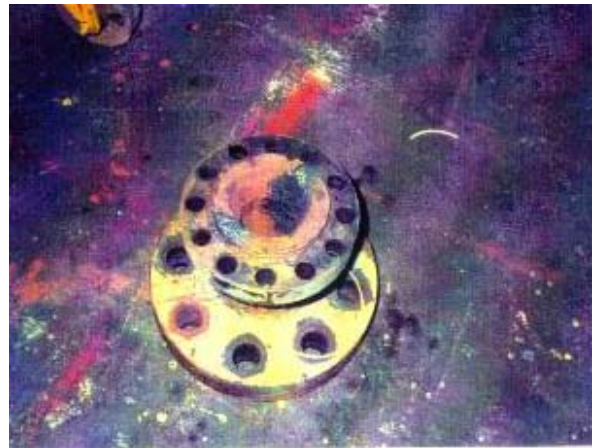
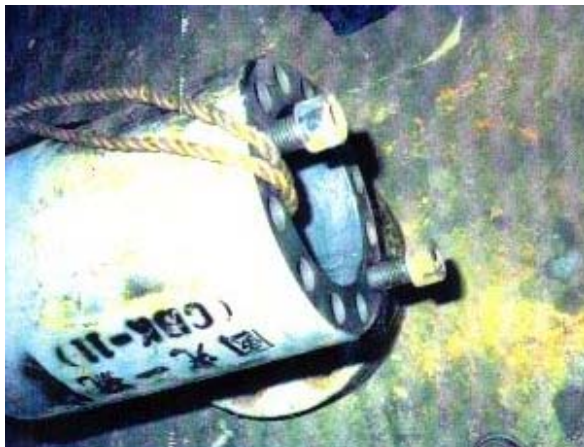
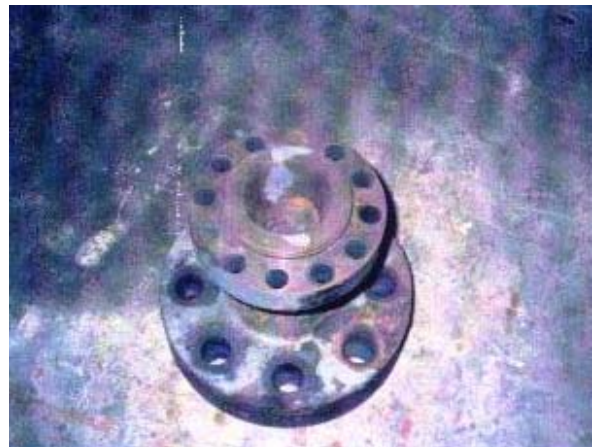
Repair of gas drilling surge valves. Abrasion due to escaping gas (2800 psi) and carrying contaminations such as e.g. sand. The repair has been carried out using Ceramium. A later inspection did not reveal any damages.
