Worldwide repairs carried out with PolymerMetal®

REP-#146

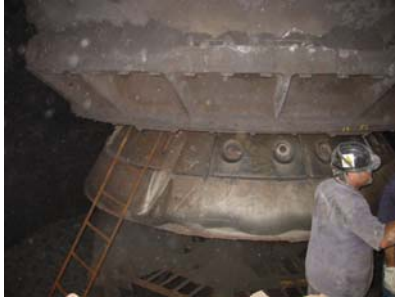
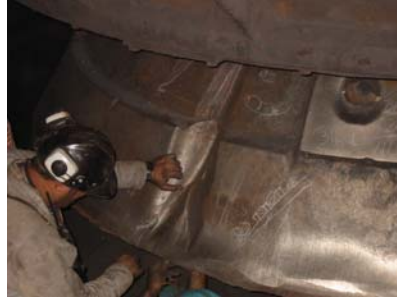
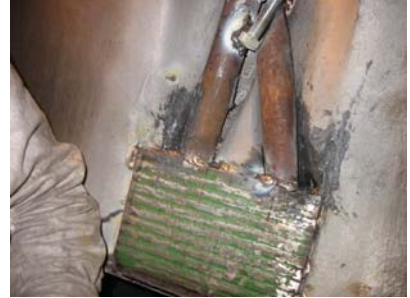
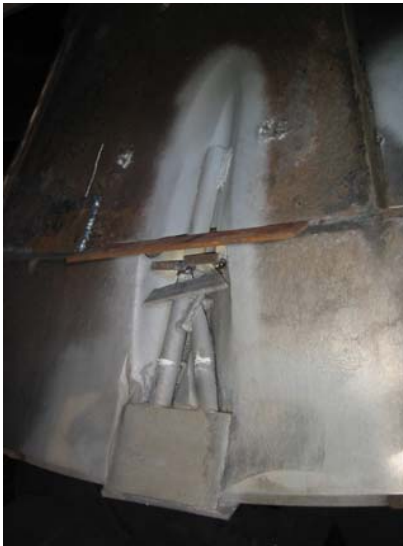
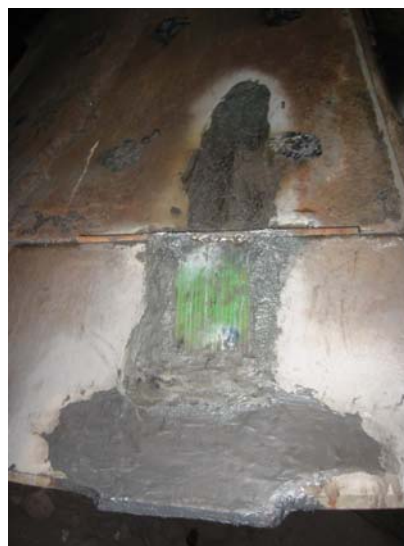
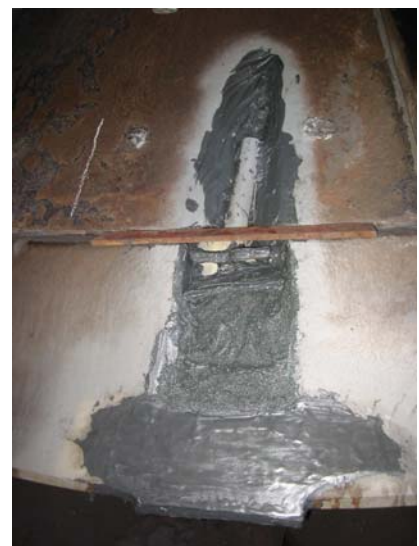
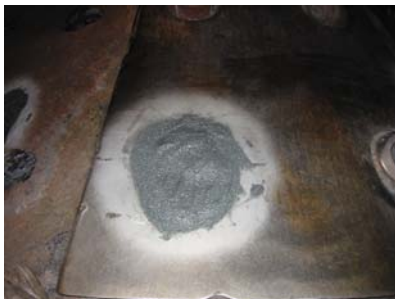
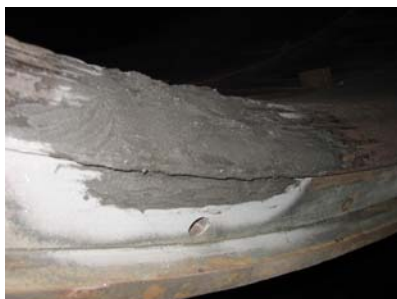
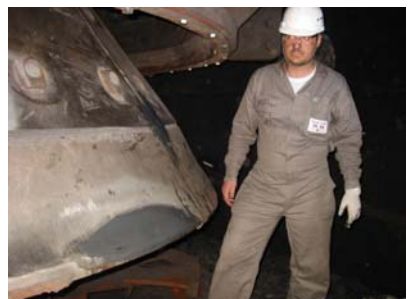
At a steelwork, heavy erosion caused damage of a blast furnace. Several areas of the conveyer cone were severely damaged due to the continuous loading with coke. Some plates were welded on the cone and then coated with Ceramium as well as some other damaged parts and the machine was put into operation successfully again.
