Worldwide repairs carried out with PolymerMetal®

REP-# 171

Fractionating column

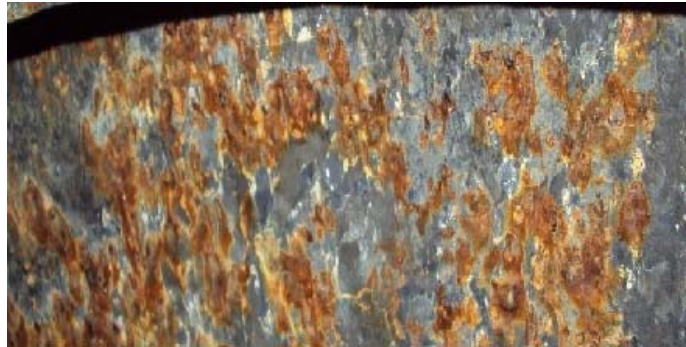
Advanced corrosion on inner tower wall of an untreated plant after 6 months in operation

In fractionating columns or cracking facilities in the chemical or petrochemical industry, there are operating temperatures of 200 - 300 °C and pressures of 0,3 - 2 bar. During the extraction of heavy fuel, side products like anthracene, creosote, naphthalene, disinfectant, etc. are generated, which will cause chemical corrosion of the inner walls in the long run. After various investigations it was decided to apply the hot-curing PolymerMetal® VP 10-500 as a protective coating on the inner walls of a new plant. VP 10-500 possesses a very good temperature and also a good chemical resistance against various chemicals originated by the oil. Untreated inner walls made of stainless steel (steel grade SA240-316L) are corroded already after 6 months. In contrast the functionality of the VP 10-500 coating is still given without any objections even after 8 years.

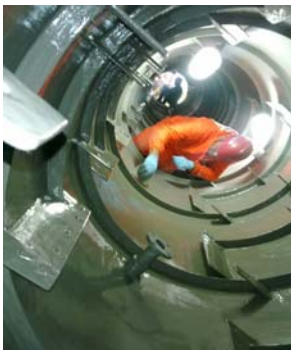
Application of VP 10-500

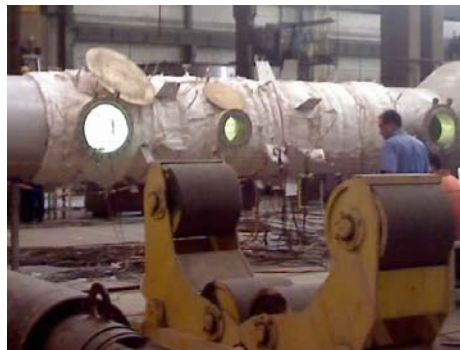
Curing with the help of wrapped heating elements

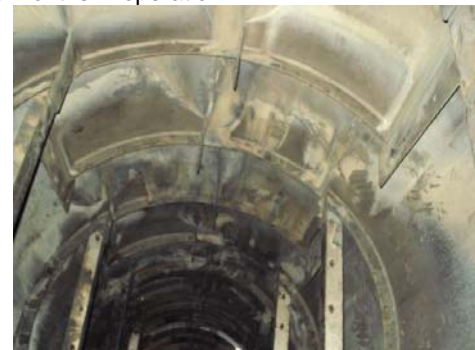
Inner tower wall after repair elements

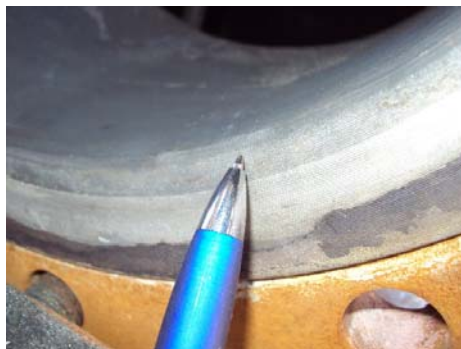
Inspection of the VP 10-500 coating after 5 years – intact!
